*Errata and Added Information to*  
**MC68360 Quad Integrated Communication  
Controller User's Manual Rev 1**

January 8, 1998

This document describes the latest information and changes to the first revision of the MC68360 user's manual.

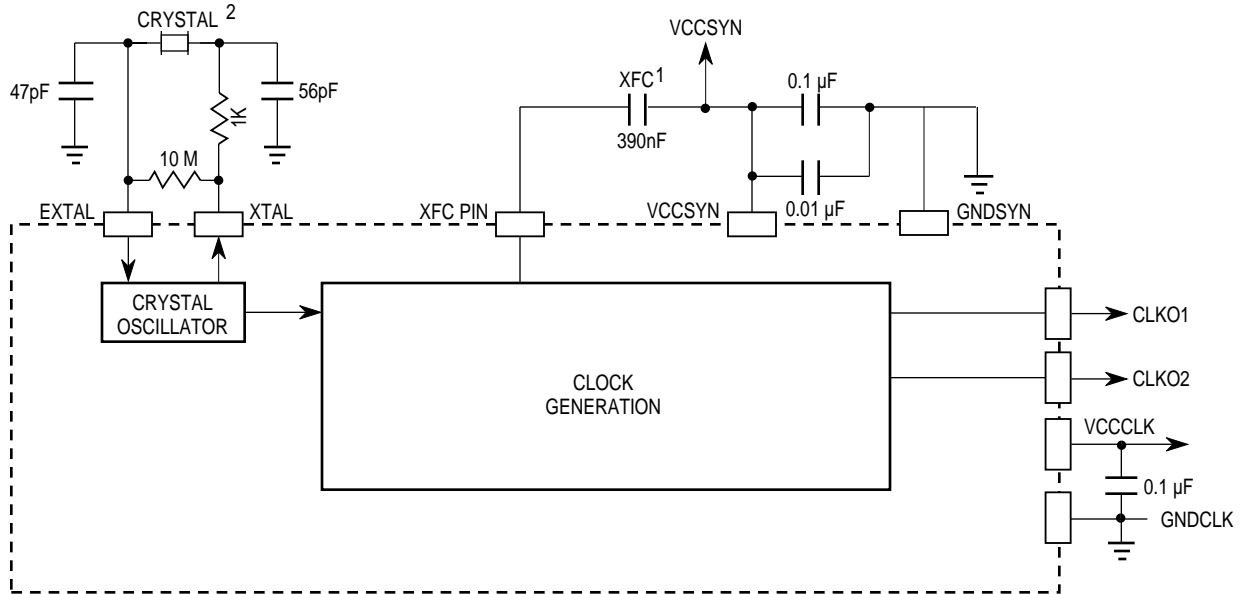
**Figure 6-6A External Components for 4.192MHz**

Also on page 6-14 the following figure should be added.

1. Must be low-leakage capacitor. See Section 10 Electrical Characteristics for recommended values.
2. Values are for 4.194MHz crystal and may vary due to capacitance on PCB.

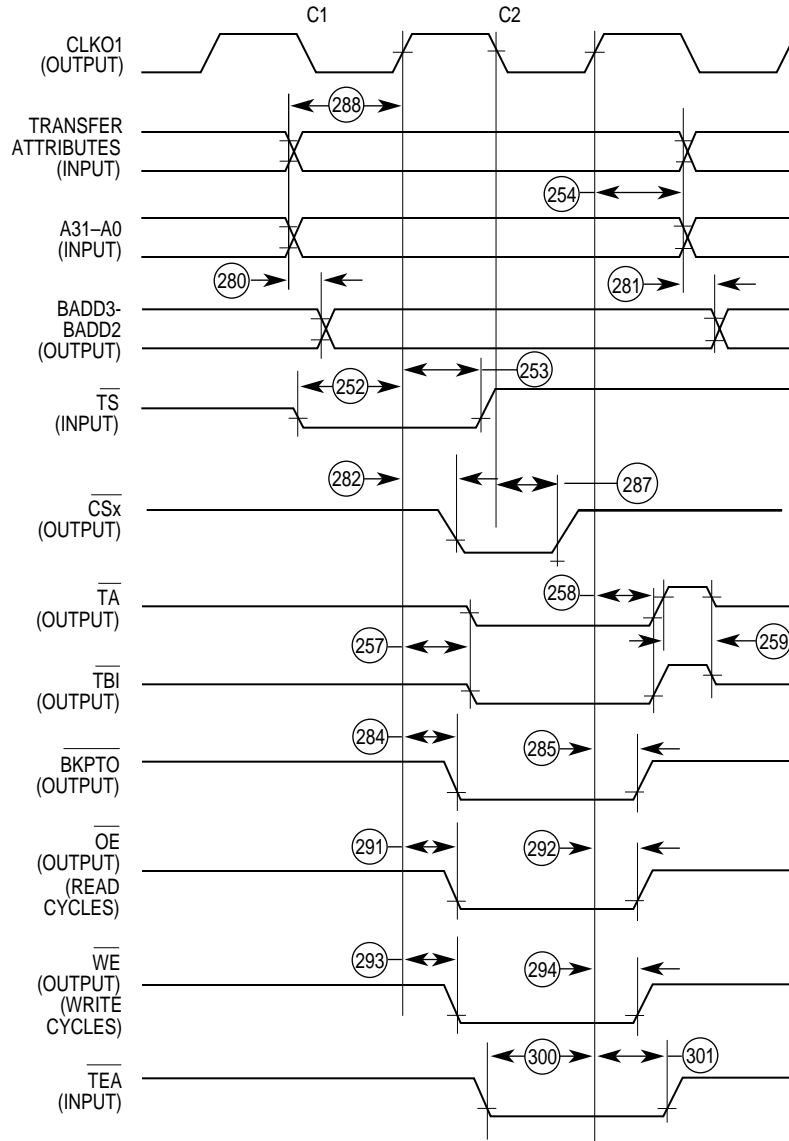
**Figure 10-44(b) MC68040/EC040 SRAM Write cycle (TSS40=0, CSNT40=1)**

The following figure should be added after figure 10-44(a)

NOTE: MC68040 Transfer Attribute Signals = SIZx, TTx, TMx, R/W, LOCK

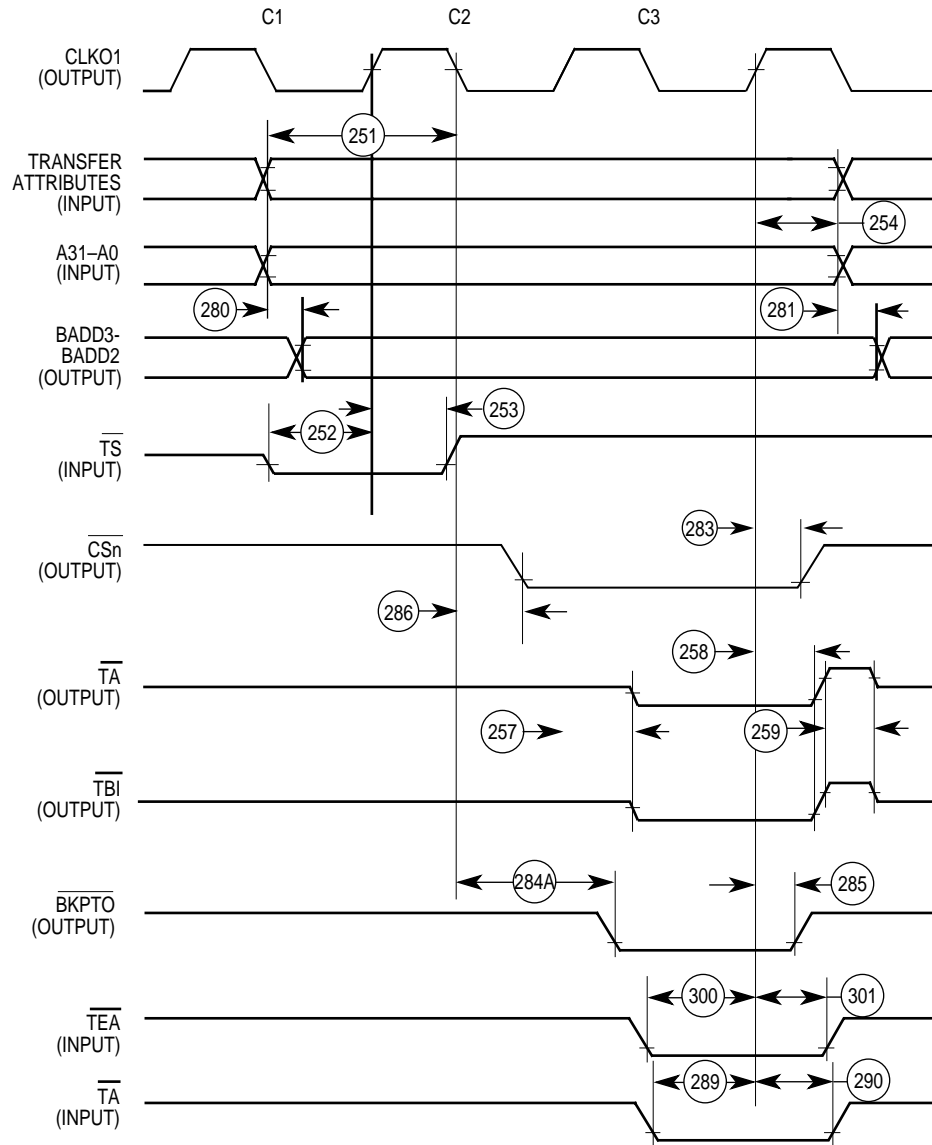
Figure 10-45(b) MC68040/EC040 SRAM Read Cycle (TSS40=1, CSNT40=1)

The following figure should be added below figure 10-45(a)

NOTE: MC68040 Transfer Attribute Signals = SIZx, TTx, TMx, R/W, LOCK  
OE and WE are not supported when TSS40 is set to 1
