Motorola C1XX Filter Replacement

The motivation to replace the baluns is to change the sensitivity of the RX path. TODO

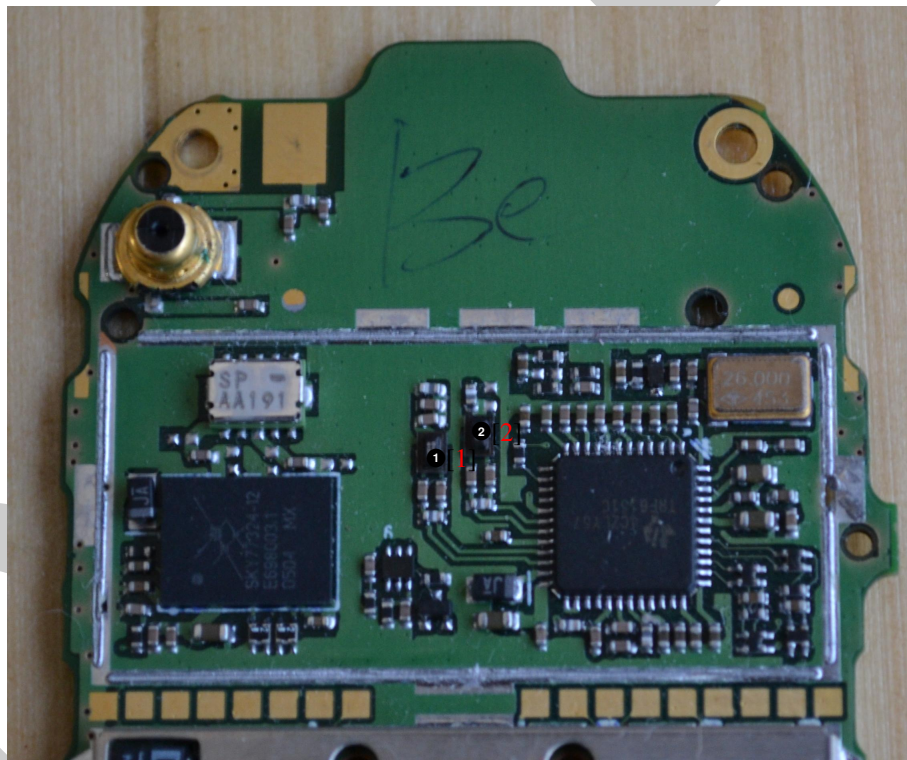
Figure 3.1: Step 1

- ❶ The black (sometimes silver) component is the GSM900 balun. Remove it from the PCB.
- ❷ The black (sometimes silver) component is the DCS1800 balun. Remove it from the PCB.

Remove the two existing baluns.

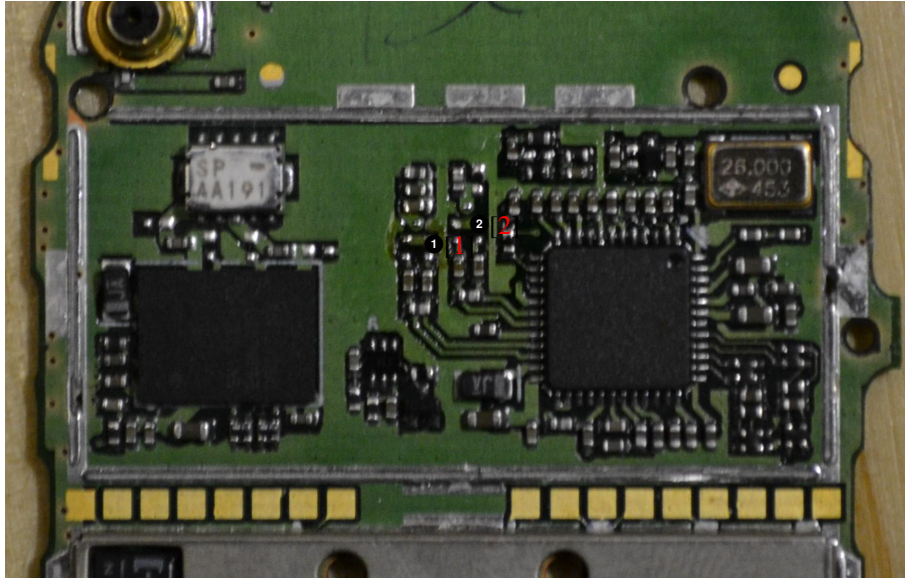
Figure 3.2: Step 2

The balun should now be removed and you should see the traces.

- ❶ The RX path for GSM900 without the balun.
- ❷ The RX path for DCS1800 without the balun.

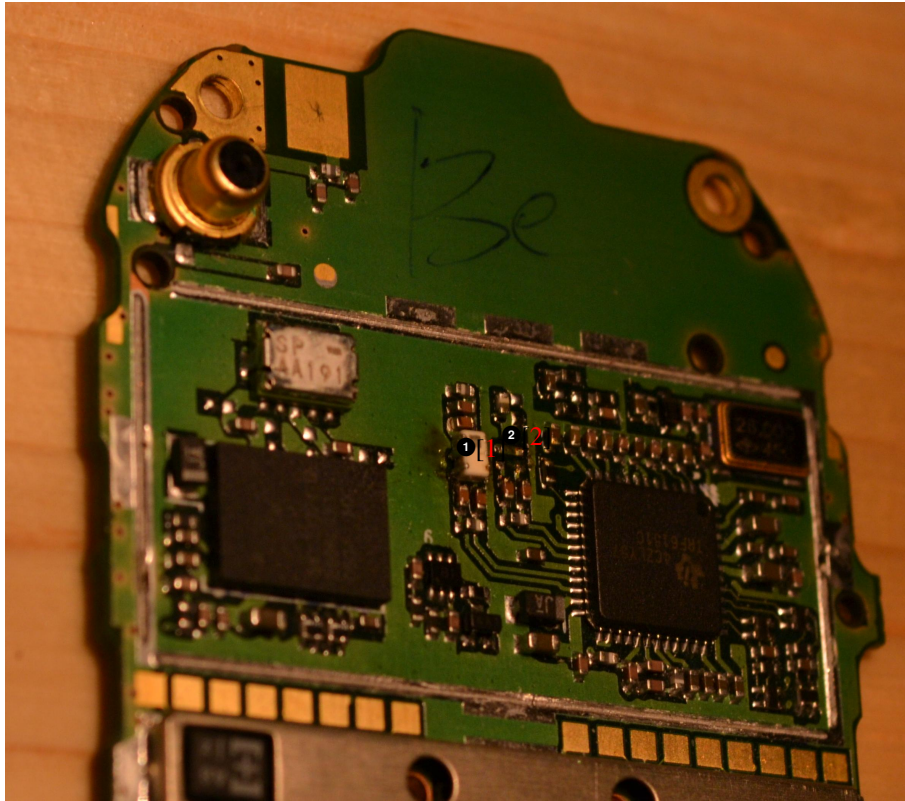
Figure 3.3: Step 5

- 1 Place the HHM1523C1 (GSM 900) here
- 2 Place the HHM1526 (DCS 1800) here

Place the new balun's on the PCB.

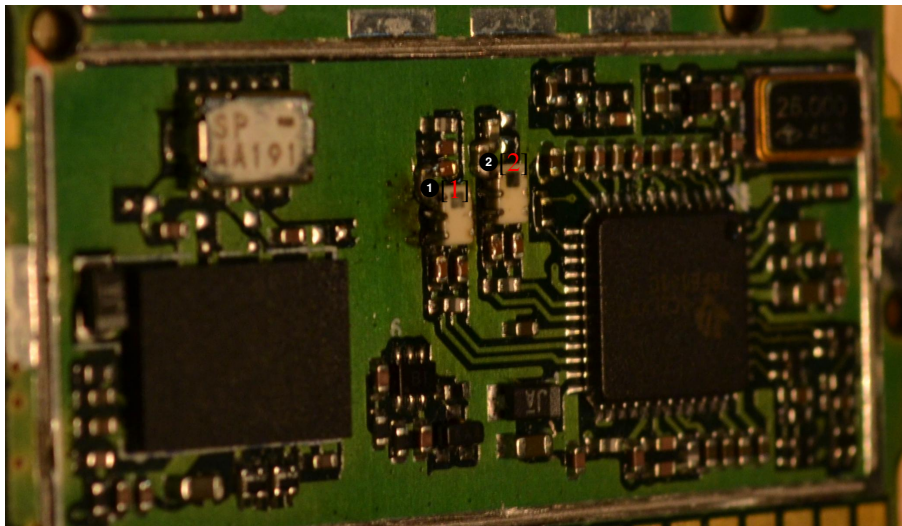
Figure 3.4: Step 7

- ❶ Place one 22 pF (04025A220JAT2A) cap here.
- ❷ Place one 15 pF (04025A150JAT2A) cap here.

Place capacitors

Sometimes the input (at the bottom of the balun) is not with caps in series and a resistor in parallel. Instead it might be without the resistors in parallel and resistors in series. Remove the resistors and place 2x the appropriate cap in series (22 pF for GSM90, 15 pF for DCS1800).
